SAS Superstructure

Daily Diary Report by Bid Item

Diary #: 810 Const Calendar Day: 296 Date: 27-Mar-2013 Wednesday

04-0120F4
04-SF-80-13.2/13.9
Self-Anchored
Suspension Bridge

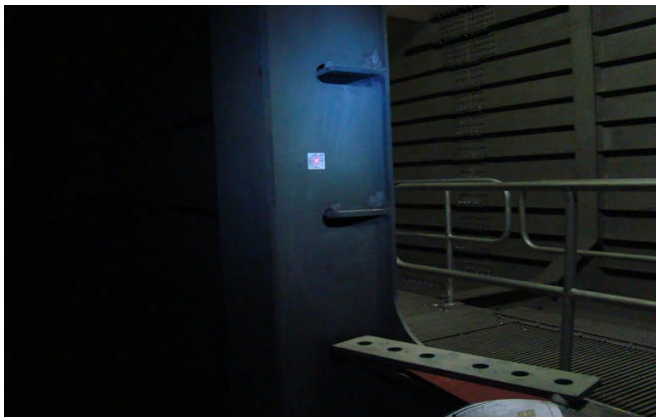
Leica reflective tape target used as a backsight for the total station, arbitrary coordinates were assumed. Notice the laser set on the target.

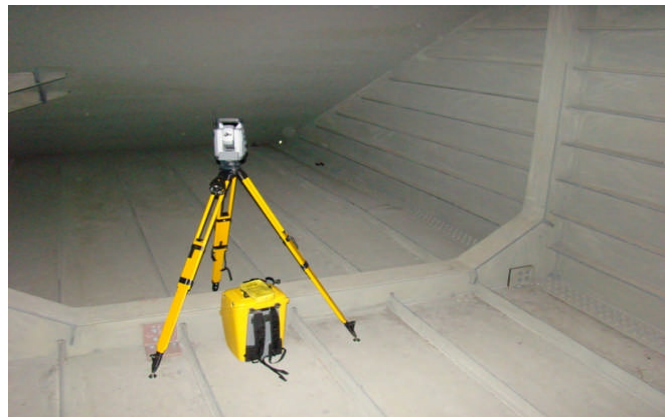
- Surveyed the deformed area in Crossbeam 8 due to the Manitowoc ringer crane boom that struck the northeast corner during the temporary truss removal accident along the W-Line from bent D to G. Shot over 800+ points with the scanning feature of the Trimble S8 total station in addition to defining local stiffeners in the crossbeam, see photos below for more details. The total time of the survey was from 1:00pm to 2:50pm where the ambient condition outside of the crossbeam was 57F with an atmospheric pressure is 29.99"Hg under overcast skies.

Location of the total station set over the longitudinal T stiffener centerline, the damage to Crossbeam 8 is to the right of the total station.
